1987 Ship Production Symposium

Paper No. 19: Evaluation of Commercially Available Wet Welding Electrodes for Potential Repair of U.S. Navy Ships

Thomas C. West, Visitor, Welding Engineering Services, and Gene Mitchell, Visitor, Naval Sea Command

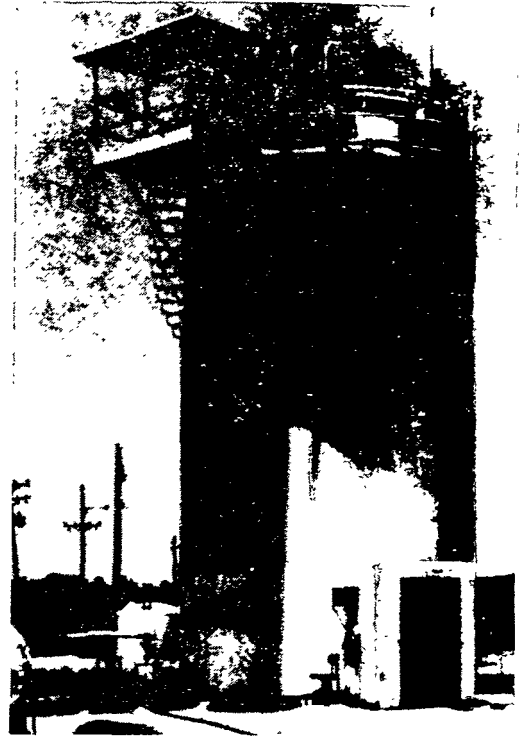
FIGURE 1. Global Divers Test Tank

Diving and welding facilities were provided by Global Divers and Contractors of New Iberia, Louisiana; The Global test tank is shown in Figure 1. The wet welding tank was 36 feet high, 20 feet in diameter, and contained sea water. The filtering system maintained clear water throughout the welding operations. The air compressor and volume tank were adequate for the support of two welder/divers working at the same time. The welding machines were both 400 ampere Miller diesel driven generators.

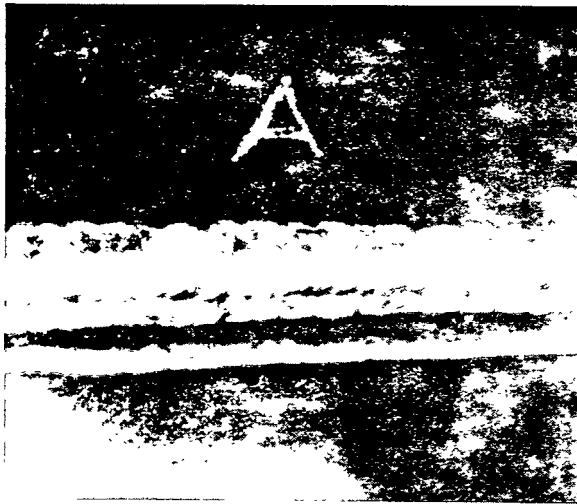
FIGURE 7. Electrode No. 1
Vertical Fillet, 33 FSW

2.5.1.1 Cruciform. All cruciform were made using the high CE DH 36 steel. Cruciform bead appearance ranged from good (Figures 7 and 8) to poor (Figures 9 and 10). The cruciform were welded in the vertical and overhead positions at a water depth of 33 feet. Three layers of weld metal were deposited in each corner (see Figure 3).

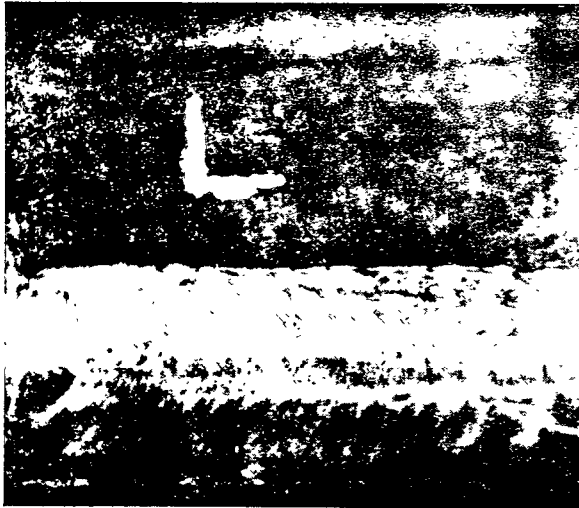
FIGURE 8. Electrode No. 3
Overhead Fillet, 33 FSW

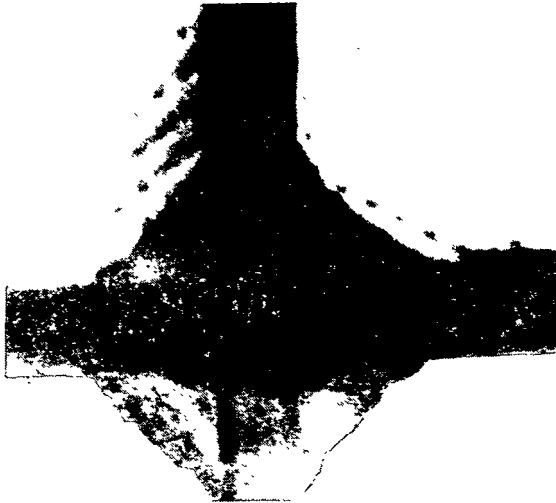
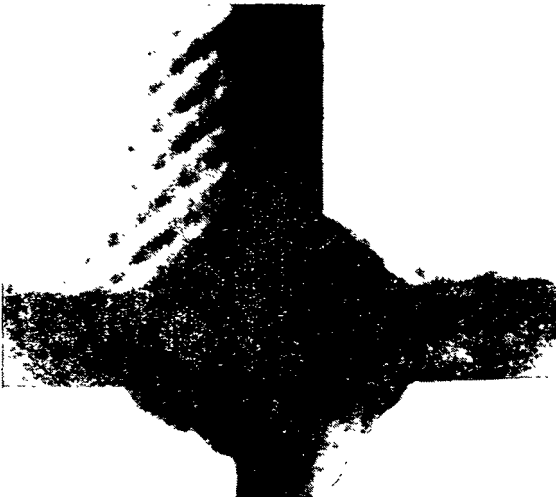
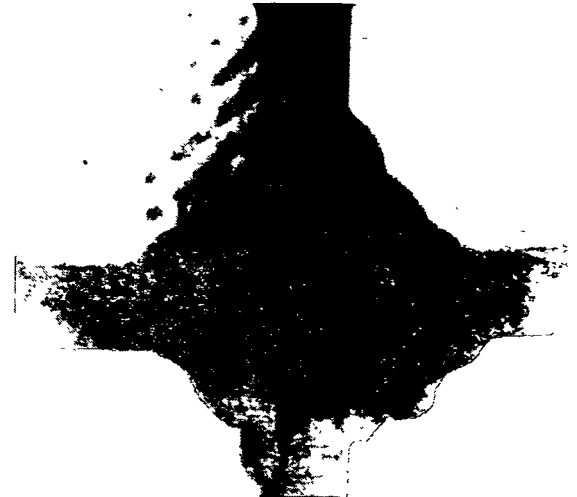
FIGURE 11. Electrode No. 1
Vertical Fillet, 33 FSW

FIGURE 13. Electrode No. 2
Vertical Fillet, 33 FSW

FIGURE 12. Electrode No. 1
Overhead Fillet, 33 FSW

FIGURE 14. Electrode No. 3
Overhead Fillet, 33 FSW

Weldability, visual and liquid penetrant inspection, and MACRO sections were evaluated and graded using the form shown in Figure 4. Representative photographs of the MACRO sections are shown in Figures 11 through

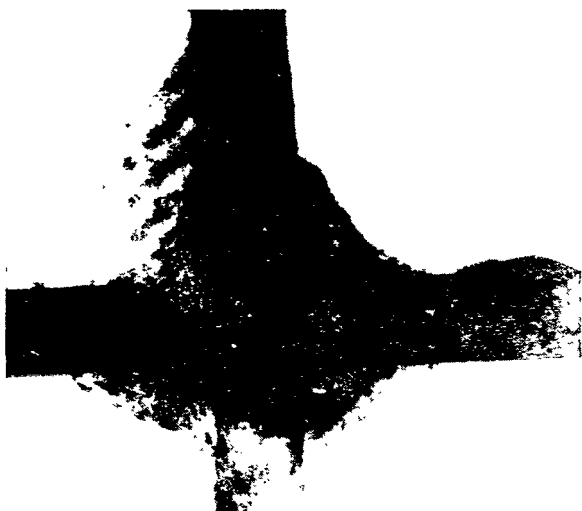
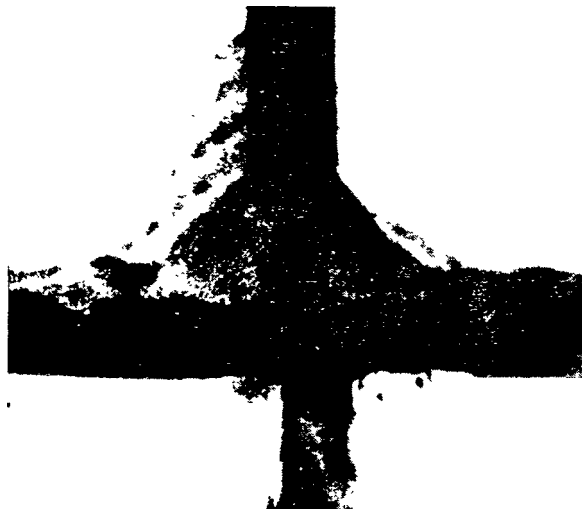
FIGURE 15. Electrode No. 4
Vertical Fillet, 33 FSW

FIGURE 16. Electrode No. 5
Overhead Fillet, 33 FSW

the cracking manifested itself through the entire thickness of the root pass of the first grooved plate weld. As a result, the grooved plate weld was not completed, and no further welding was attempted using this electrode. Electrode No. 4 and No. 5 NACROS are shown in Figures 15 and 16.

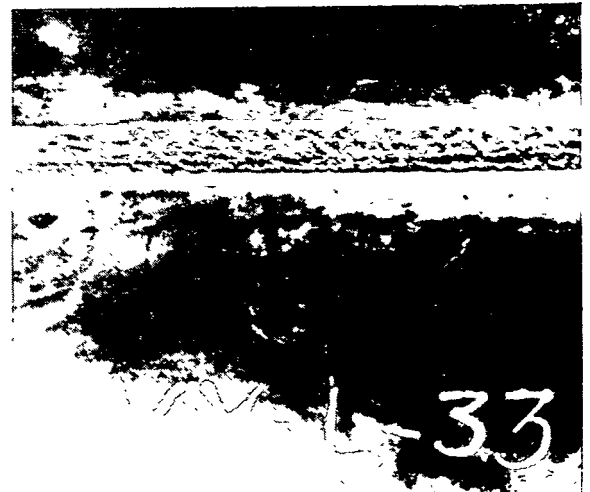
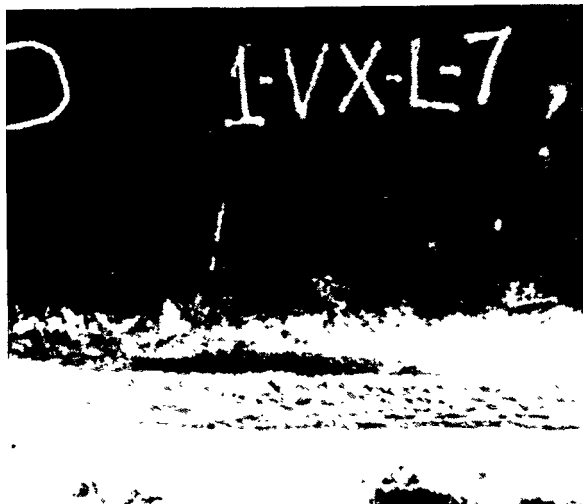
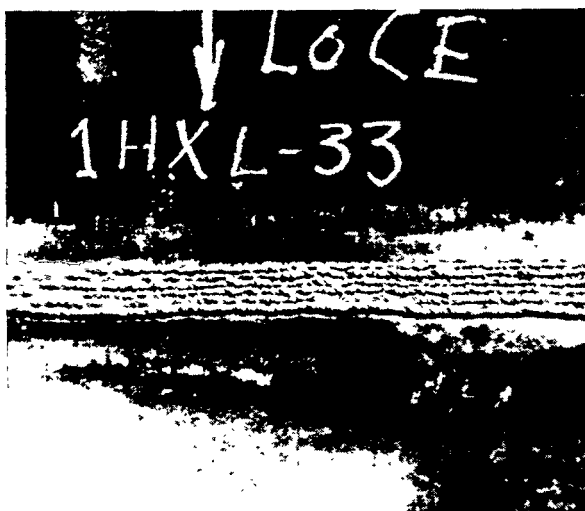
FIGURE 21. Electrode No. 1
Vertical Qualification
33 FSW

FIGURE 22. Electrode No. 1
Vertical Qualification
7 FSW

FIGURE 23. Electrode No. 1
Horizontal Qualification
33 FSW

Electrode Number 1 did not demonstrate the same degree of weldability at 7 FSW as at 33 FSW. The electrode could not be qualified in the overhead position at 7 FSW due to the high crowned, narrow beads. The Y plate could not be completed; the X plate was completed at 7 FSW in the overhead position, and the rough capping beads were ground off prior to radiographic inspection; however, the weld failed the AWS D3.6 Type B acceptance standards due to extensive slag and lack of fusion.

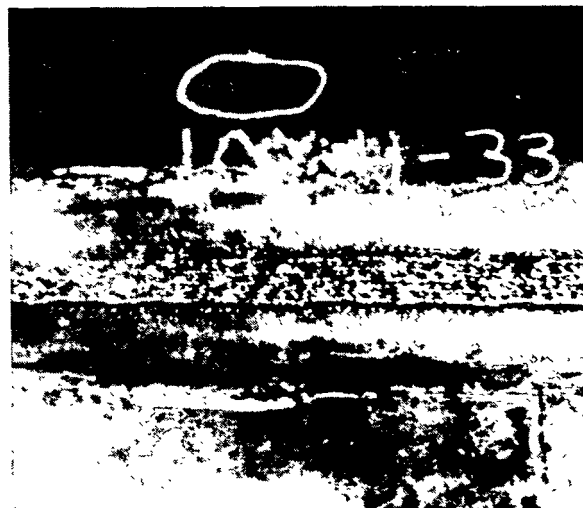
FIGURE 24. Electrode No. 1
Overhead Qualification
33 FSW

in the overhead position at both water depths, such that one test plate (10Y-H-33, Figure 24) failed to meet any surface inspection acceptance standards. The electrode also tended to undercut in the horizontal welding position, but to a lesser extent than in the overhead position.

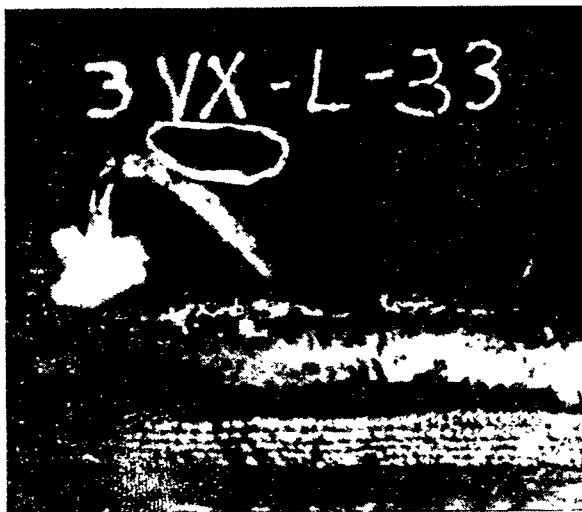
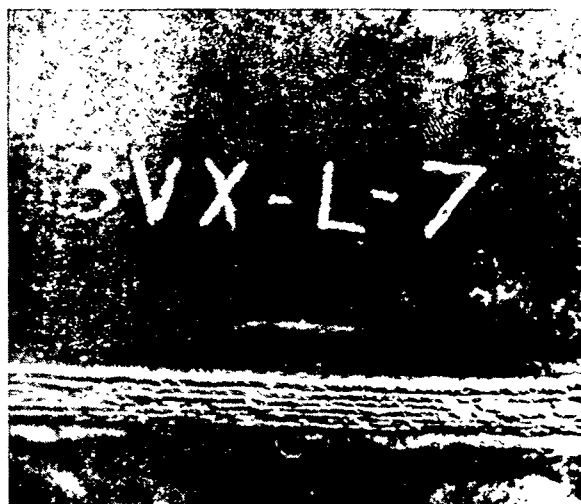
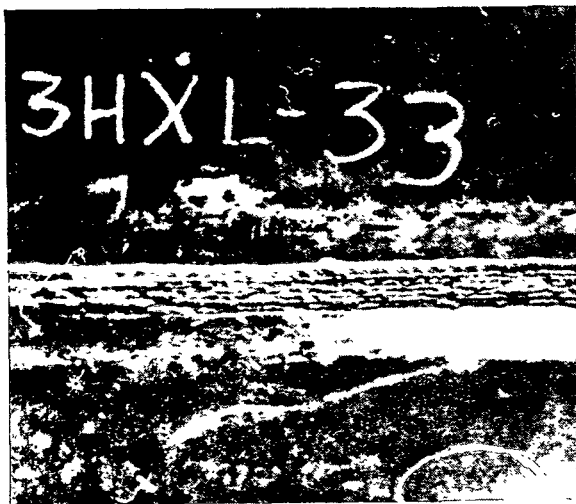
FIGURE 25. Electrode No. 3
Vertical Qualification
33, FSW

FIGURE 26. Electrode No. 3
Vertical Qualification
7 FSW

FIGURE 27. Electrode No. 3
Horizontal Qualification
33 FSW

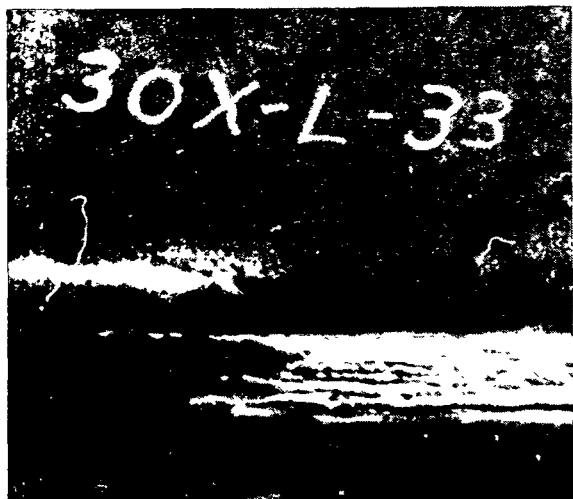
FIGURE 28. Electrode No. 3
Overhead Qualification
33 FSW

Numbers 1 and 3 were found to be suitable for making all-position welds in mild steel, with the exception of Electrode No. 1 in the overhead position at 7 FSW. Both electrodes can be used by a welder/diver with average welding ability; weldability and ease of slag removal make the electrodes usable with minimal training. Overhead welding is more difficult than the other positions due to decreased visibility of the welding arc; this is a result of the bubbles being hindered, by the plate, in their movement toward the water surface. This results in capping beads which are a little more irregular than those of other welding positions (see Figures 24, 28 and 29). Figure 28 shows 50 percent of the length of the cap removed by grinding; this was done to determine whether or not the irregular ("ropy") bead profile would interfere with radiographic film interpretation. It was found that the cap did not interfere with film interpretation. The undercut shown in Figure 28 is less than 1/16 inch in depth.

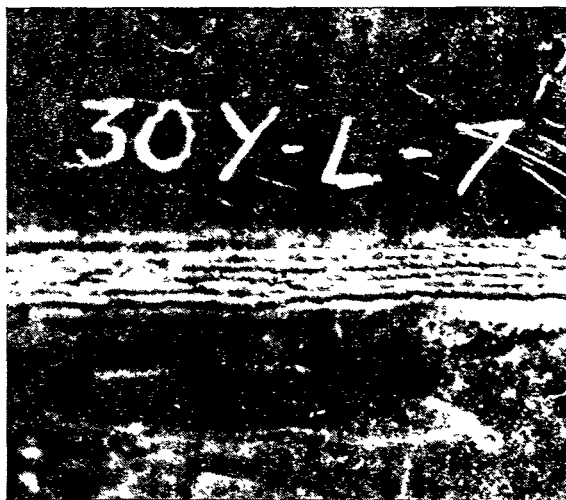
FIGURE 29. Electrode No. 3
Overhead Qualification
7 FSW

FIGURE 30. Electrode No. 3
Vertical Qualification
33 FSW

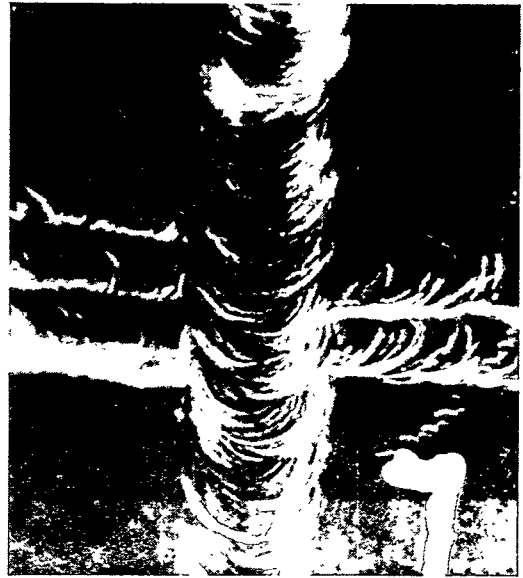
FIGURE 31. In-Air Butt Weld
(E7018, Single Pass Cap)
Intersecting a Wet Butt
Weld (Electrode No. 3)
Vertical, 33 FSW
